ANNUAL INSPECTION REPORT FOR VIRGINIA REGULATED IMPOUNDING STRUCTURES

Name of Dam: Possum Point Power Station Ash Pond ABC Dam Inventory Number: NA
Owner's Name: Dominion Generation Location-County/City: Prince William County
Contact Person (if different from above): Michael Winters, P.E.
Owner's Address: 5000 Dominion Boulevard, Glen Allen, VA 23060 Hazard Classification: Low
Name of reservoir: Possum Point Power Station Ash Pond ABC
Purpose of reservoir: contains coal ash
Telephone No.: (Residential) 804-347-9451 (Business) 804-273-2376, cell: 804-347-9451
Other means of communication: michael.j.winters@dom.com

Date of This Inspection April 2, 2014
Date of Last Inspection unknown

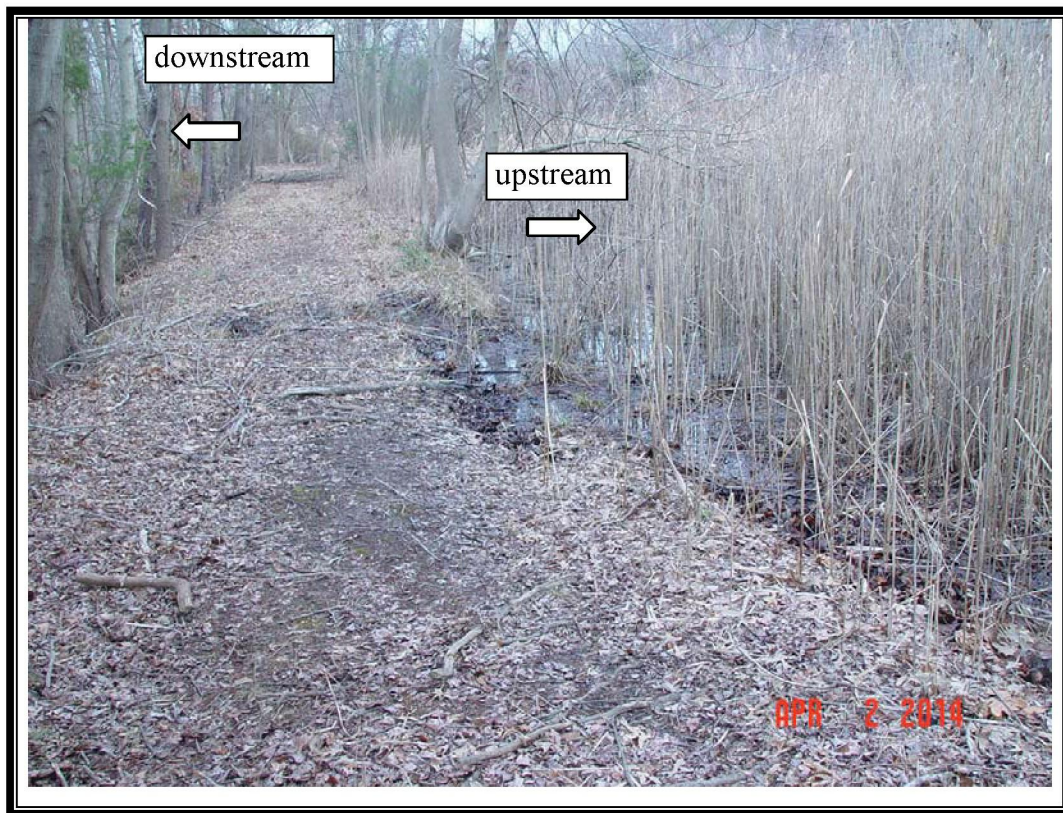
PHOTO 1
Dam crest, typical.

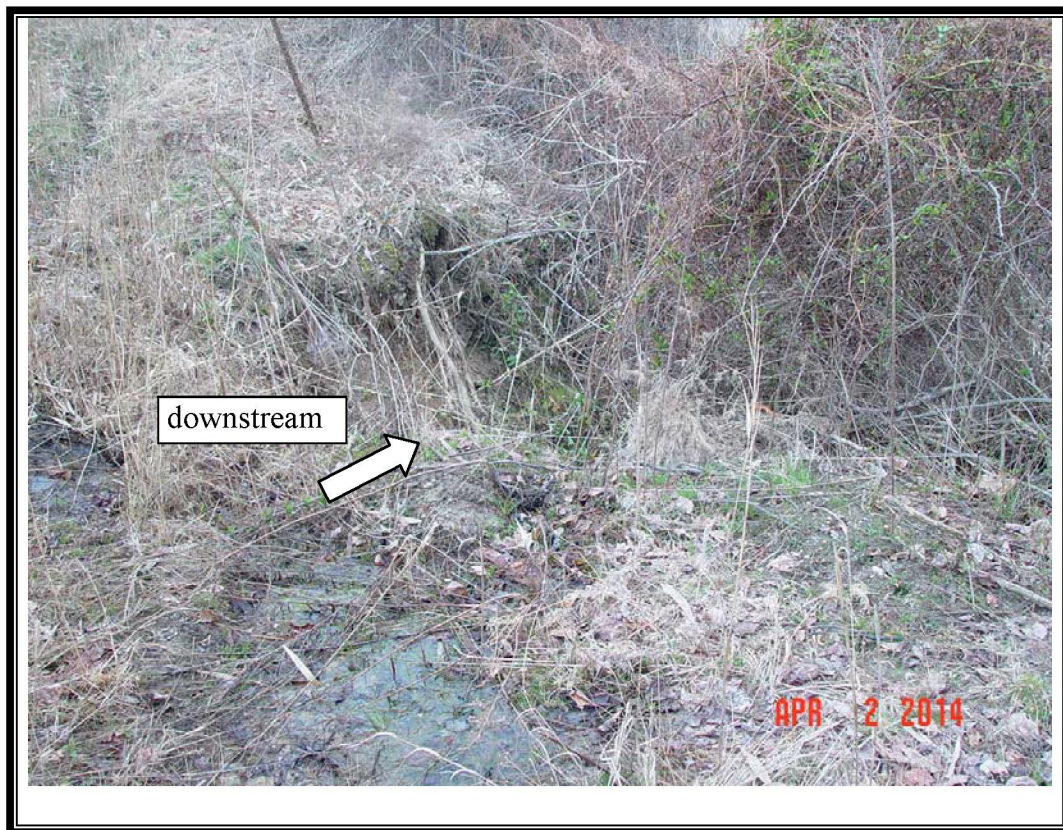
- a. Any alteration made to the embankment? none
- b. Erosion on embankment? Erosion on A and C sections. See attached photos.
- c. Settlement, misalignment or cracks in embankment? Apparent settlement on sections A and C. No cracks or misalignment observed.
- d. Seepage? If so, seepage flow rate and location (describe any turbidity and observed color within the flow): No seepage observed on the embankment.

PHOTO 2
Erosion of crest and downstream slope.

Recommendations: Perform subsurface exploration, stability analysis, hydraulics and hydrology analysis. Repair erosion and settlement and remove trees from upstream and downstream slopes. Place sand bags while obtaining permits and preparing design. Remove the final downstream section of the outlet pipe.

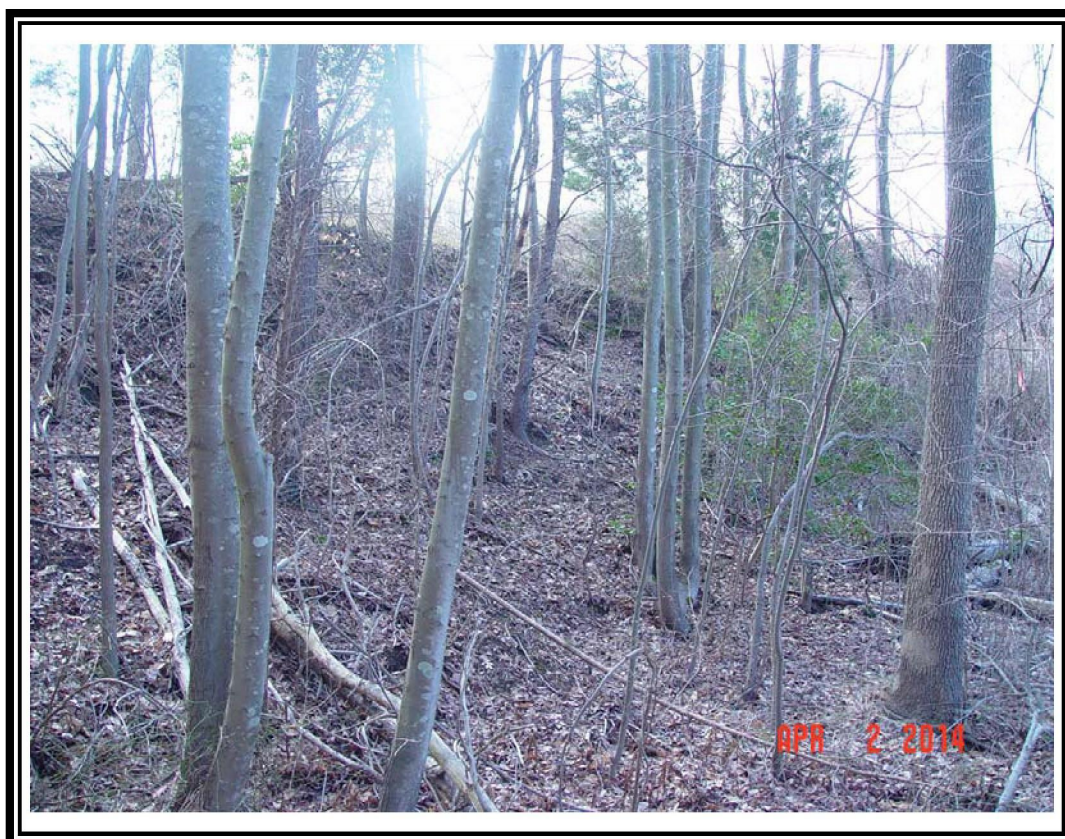
- a. Woody vegetation discovered? Heavy

PHOTO 4
Downstream slope, typical.

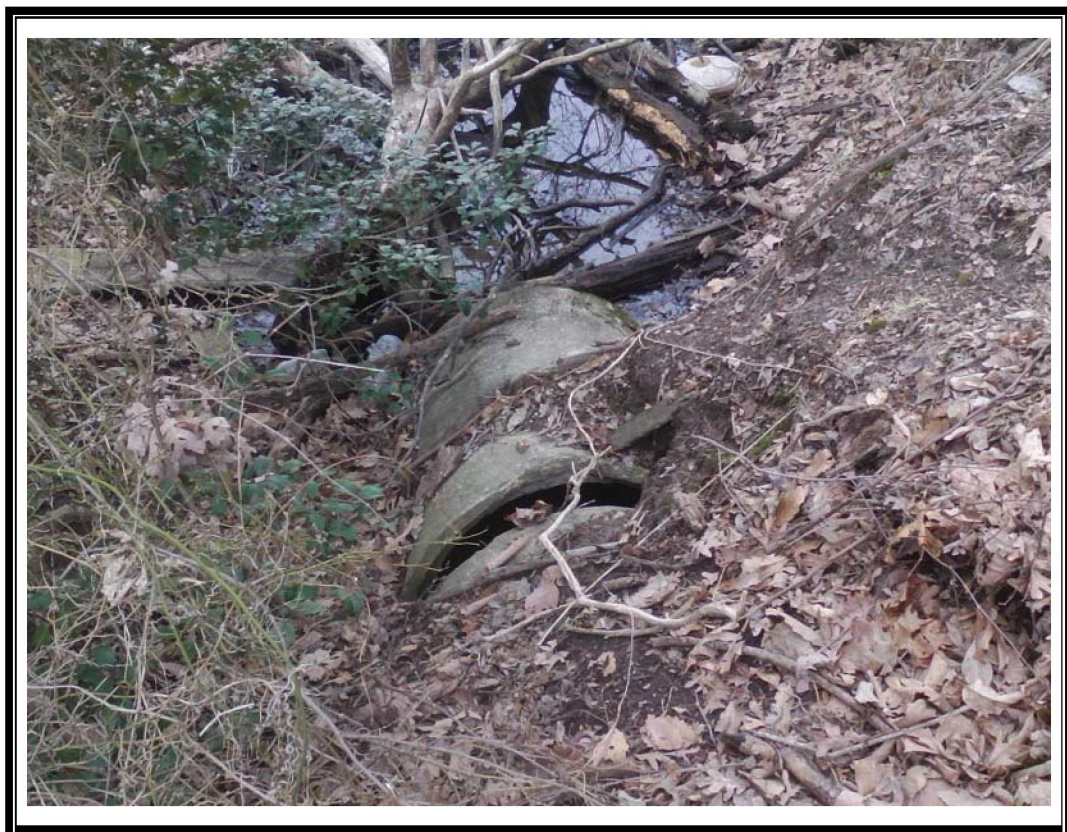
- b. Describe any deflection or damage to the pipe: The final downstream segment of pipe is disconnected. See photo attached.

PHOTO 5
Outlet pipe, downstream end, looking downstream.
